Mechanisms of Hemolysis With Mitral Prosthetic Regurgitation Study Using Transesophageal Echocardiography and Fluid Dynamic Simulation

MARIO J. GARCIA, MD, PIETER VANDERVOORT, MD, WILLIAM J. STEWART, MD, FACC,
BRUCE W. LYTLE, MD, FACC, DELOS M. COSGROVE III, MD, FACC,
JAMES D. THOMAS, MD, FACC, BRIAN P. GRIFFIN, MD, FACC

(*J Am Coll Cardiol* 1996;27:399-406)

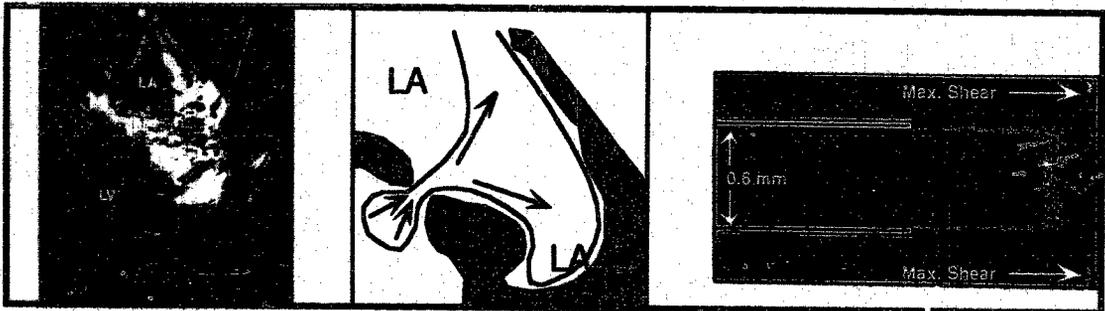
B. Collision

2) *Collision*: In a rectangular grid with the dimensions of the preceding model, two parallel horizontal walls were simulated at a distance of 0.3 mm from the horizontal midline and extending through a distance of 1 mm. A vertical wall was simulated at 1.5 mm distal to the end of the horizontal walls. A laminar flow jet with a peak velocity of 5 m/s with a horizontal vector was simulated as passing between the two horizontal walls and colliding with the vertical wall.

A paravalvular regurgitant jet is suddenly decelerated when colliding with the left atrial appendage wall.

contact with the solid object, measured in the y axis. The maximal shear value obtained was measured at 6,000 dynes/cm². In the collision model the points of maximal shear were located in contact with the vertical wall at the regions where the flow changes direction from the horizontal to the vertical axis. The maximal shear rate obtained was 4,500 dynes/cm² measured in the x axis. In both rapid acceleration and free jet models the maximal shear occurred close to the border of the orifice toward the distal flow. The maximal shear rate was 4,500 dynes/cm² and 925 dynes/cm² in the y axis for each model, respectively. In the slow deceleration model the maximal shear was found at either edge of the orifice and measured 950 dynes/cm² in the x axis.

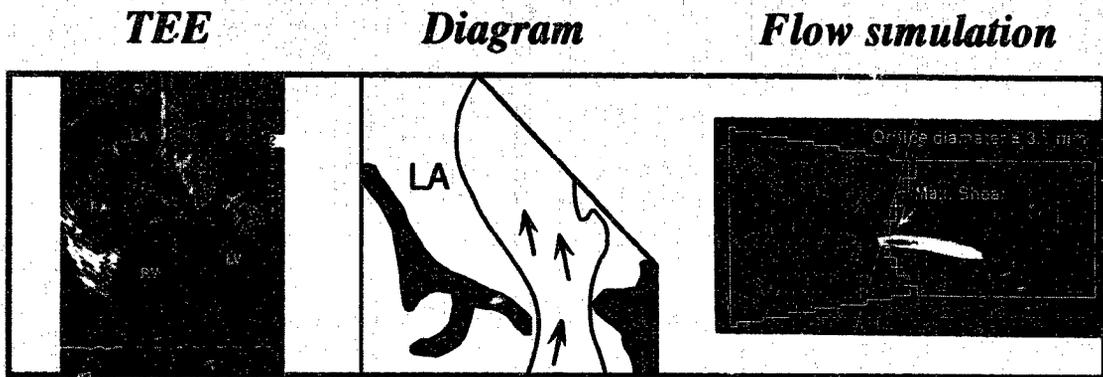
A. Free Jet

4) *Free jet*: This model was similar to model 3 but had an orifice diameter of 4 mm. The proximal flow velocity was increased to achieve a peak velocity of 5 m/s at the orifice.

A central jet travels through a large orifice in a bioprosthesis with a torn cusp.
